June 1945 as
Advance Restricted Report L5F01a

EFFECT OF FABRIC DEFLECTION AT HIGH SPEEDS ON THE
AERODYNAMIC CHARACTERISTICS OF THE HORIZONTAL
TAIL SURFACE OF AN SB2D-1 AIRPLANE

By Carl F. Schueller and Peter F. Korycinski

Langley Memorial Aeronautical Laboratory
Langley Field, Va.

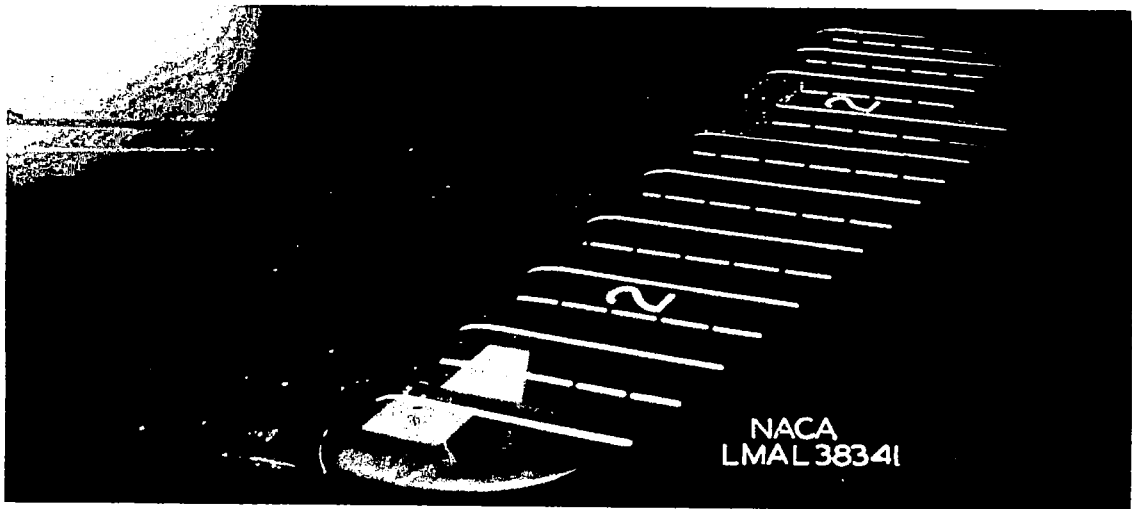
(a) Upper surface.

(b) Lower surface.

Figure 6.- Static condition for elevator 2.

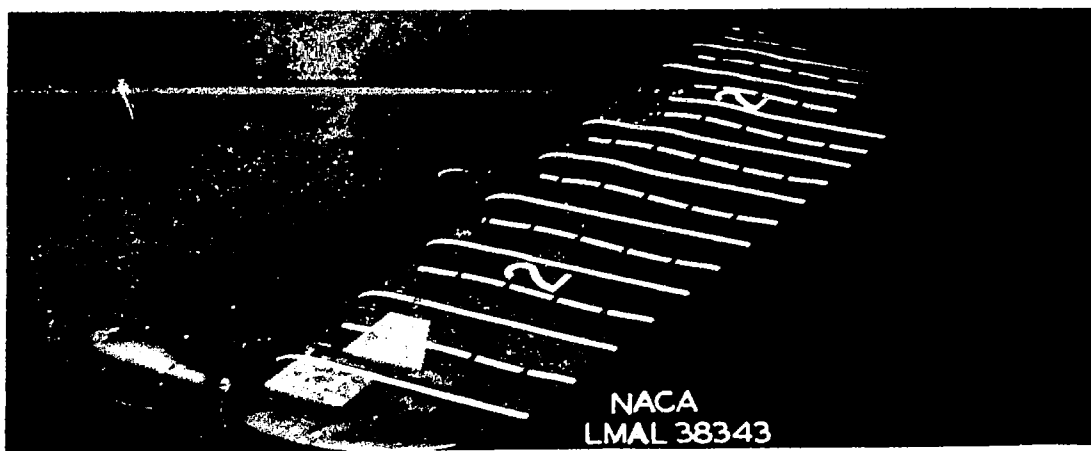
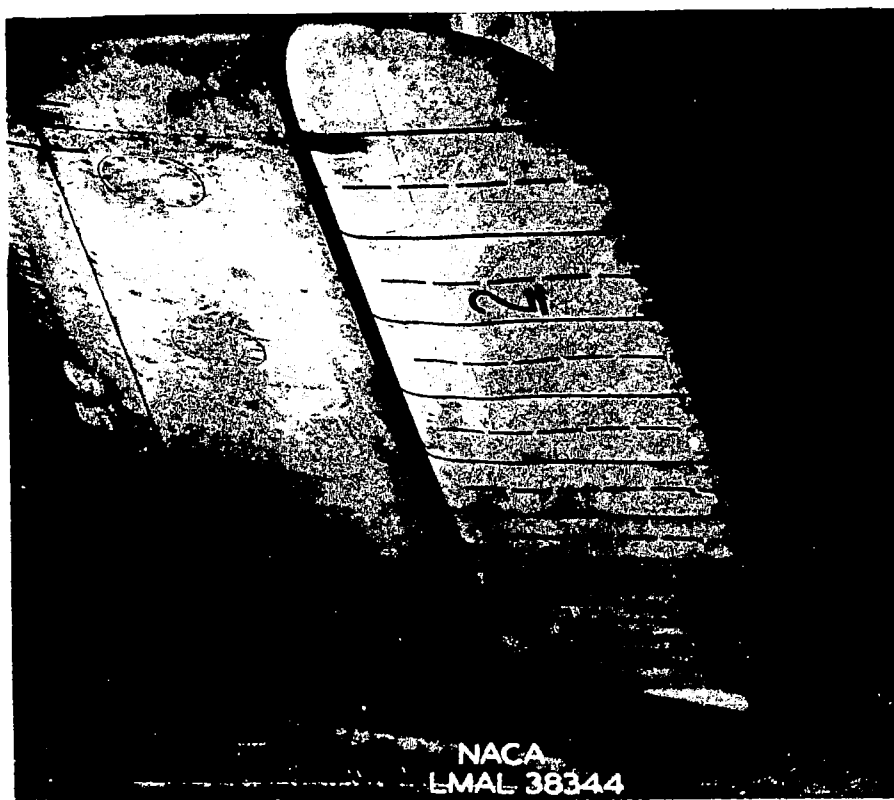
Figure 10.- Fabric deflection of elevator 2. $M = 0.62$;
 $\alpha = 3^\circ$; $\delta = -0.7^\circ$; elevator vents at trailing edge.

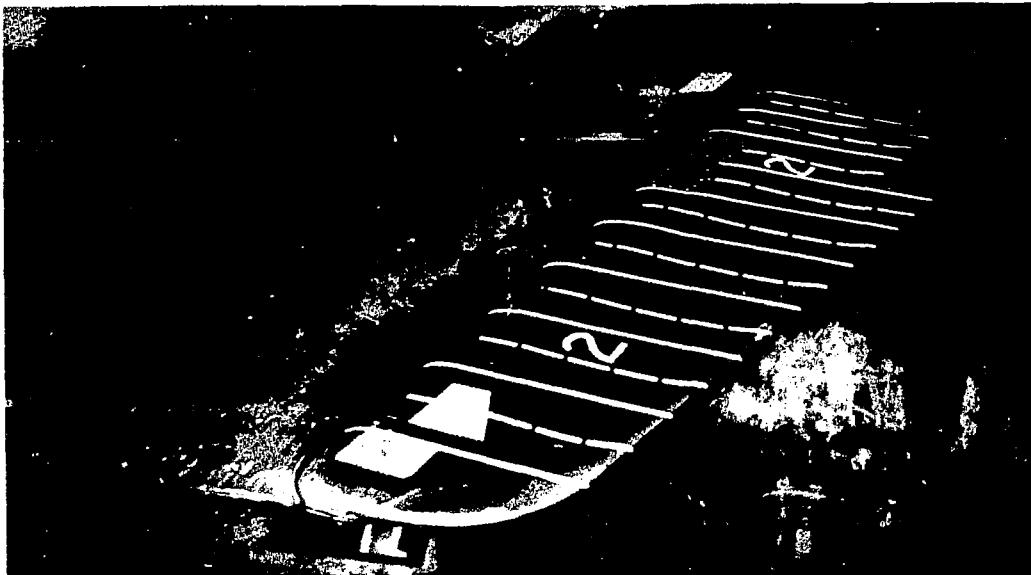
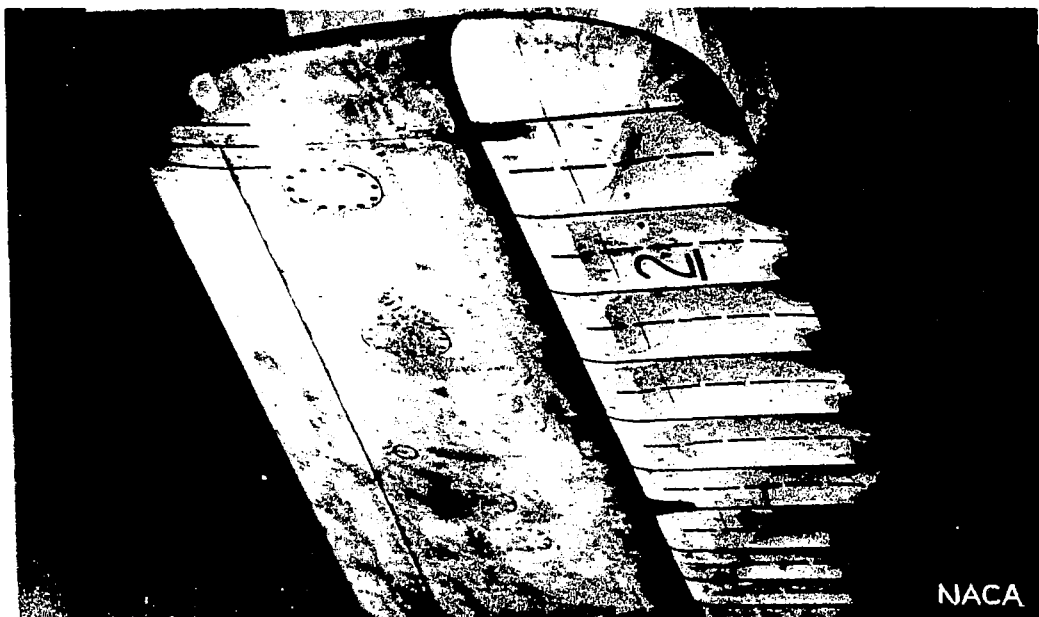
Figure 20.- Fabric deflection of elevator 2. $M = 0.55$;
 $\alpha = 0^\circ$; $\delta = 4^\circ$; elevator vents at leading edge.

Figure 20 is a photograph of the fabric deflection with vents at the elevator leading edge for $\alpha = 0^\circ$, $\delta = 4^\circ$, and $M = 0.55$. Comparison of figures 20 and 9 shows that the upper-surface bulge is changed to depression with vents at the elevator leading edge, except for a small local bulge at the upper surface near the inboard hinge. It is apparent from figures 19 and 20 that location of the vents at the elevator leading edge will eliminate the danger of the fabric pulling loose from the ribs and failing for elevator angles up to at least 4° .
